Where art meets science

Allan Matthews describes restoring an upper left first molar with durable composite filling, overcoming challenges presented by a deep cavity and thin palatal wall

Dr Allan Matthews BDS

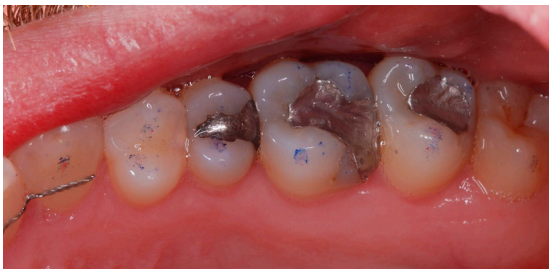
A straightforward examination was carried out and it was determined that the gentleman was clenching his teeth and the load being applied to the molar was causing a flexing of cusps. The small portion of remaining distopalatal wall was translucent with a ditched margin.

There was no probing depth identified in this area and it was therefore unlikely that a crack had propagated down the root surface. A lateral excursive slide on the distobuccal cusp was also recorded (Figure 1).

Figure 1: The load applied to the upper left first molar was causing flexing of cusps and there was a lateral excursive slide on the distobuccal cusp

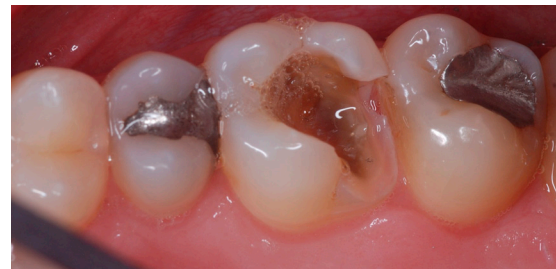
The amalgam was removed to reveal an extensive cavity. A crack was indeed found towards the buccal aspect of the distal margin.

Figure 2 shows the crack visible just beyond the

Figure 2: The amalgam was removed and a crack was found towards the buccal aspect of the distal margin

contact point. The distobuccal wall was determined to be of adequate thickness to attempt a composite restoration with careful control of lateral excursive guidance.

The procedure was performed in a single, one-hour appointment, to permit investigation of any potential cracks. The preparation was refined for smooth margins and the crack was cleared to sound enamel.

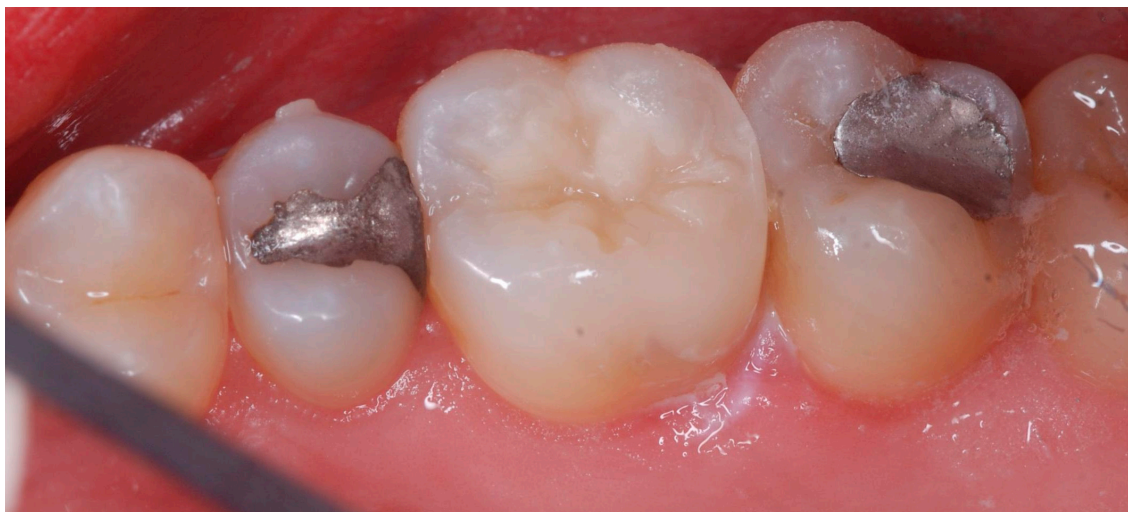
Figure 3: The filling was converted to class I, by initially using Venus Pearl A2 shade to restore the distopalatal wall, followed by a core of OMC to replicate the dentine

A combination of Opaque Medium Chromatic (OMC) dentine shade and A2 universal shade was applied in a layered technique to give warmth to

the structure. The filling was converted to class I by initially using the A2 shade to restore the distopalatal wall, followed by a core of OMC to replicate the dentine (Figure 3).

The cusps were built and shaped one by one with A2 shade, assisted by the use of Kulzer Signum liquid modelling resin and a probe to create a more natural anatomical appearance. Compaction was carried out with a ball burnisher.

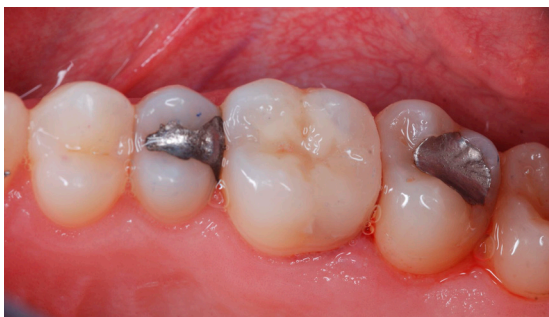
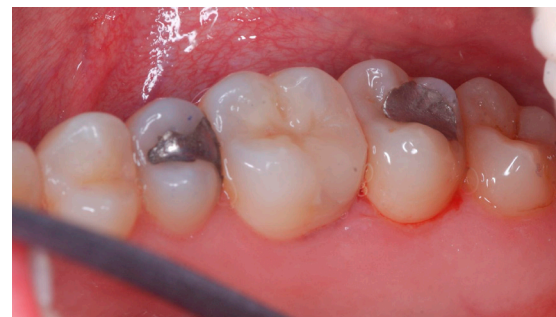
Figures 4 and 5: The composite offers high strength and polishability, and superior handling with a creamy consistency

Although an onlay may ultimately be needed, I am also confident that the Venus Pearl restoration will be as effective as a laboratory-made inlay.

I put this down to the robust nature of the composite, which offers high strength and polishability, and superior handling with a creamy consistency (Figures 4 and 5).

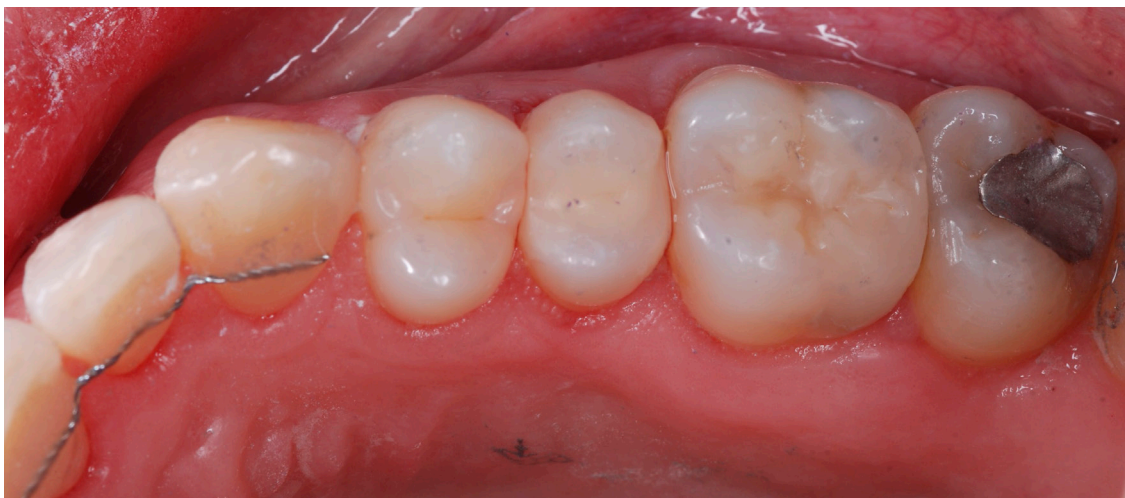
Figure 6: Both fillings after treatment was concluded on the adjacent premolar

The amalgam in the premolar was exceptionally flat and, as a clencher, the patient was hypersensitive to biting changes. This meant a loss of the fine anatomy in the restoration after adjustment. The restoration should function well, however, and fits the occlusal scheme, sealing the dentine while providing a more aesthetic result.

Since the upper left first molar was restored, the patient has also had an amalgam filling replaced on the adjacent premolar (Figure 6).
