# Caries management with nano-hybrid science

**Vishaal Shah** presents a case in which the challenges of treating caries were overcome with skill, attention to detail and appropriate selection of his 'go-to' equipment and materials

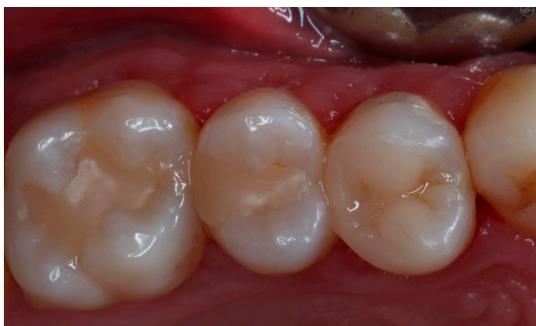
There was an anatomically inadequate disto-occlusal composite restoration on the UL5, which showed signs of leakage and distal caries at the base of the restoration (Figure 1).

**Figure 1:** An anatomically inadequate disto-occlusal composite restoration on the UL5 showed signs of leakage, and distal caries at the base of the restoration

The treatment options included doing nothing, replacing the restoration on the UL5 and assessing the UL6 after cavity preparation or, should caries be detected on the UL6, restoration of both teeth with either a high copper content amalgam or high filler content composite resin material.

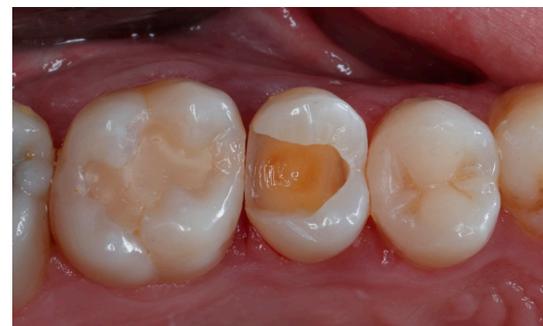
**Figure 2:** Cavity preparation commenced with careful removal of the UL5 composite

Local anaesthetic was administered to the patient by buccal infiltration. Cavity preparation commenced with removal of the UL5 composite (Figure 2), taking care to conserve as much tooth structure as possible and prevent damage to the UL6.

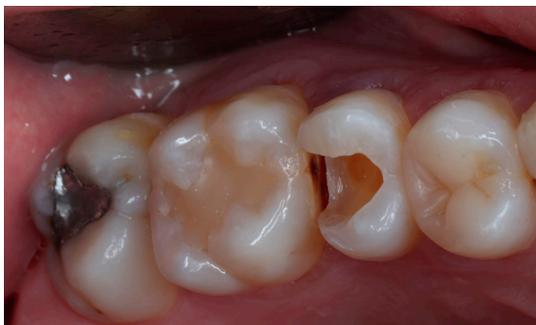
**Figure 3:** Stained and carious enamel and dentine were noted on the mesial surface of the UL6 following completion of the initial cavity preparation on the UL5

Stained and carious enamel and dentine were noted on the mesial surface of the UL6 following completion of the initial cavity preparation on the UL5 (Figure 3). The patient was shown photographs of the teeth and the extent of the caries in the UL5. The mesial caries on the UL6 was also photographed and explained to the patient.

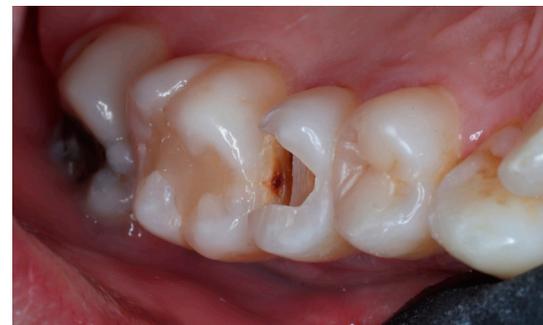
**Figure 4:** Removal of the caries on the UL6 mesial surface only was planned. Access would be from the distal cavity of the UL5

The initial plan was to remove the caries on the mesial

surface only by accessing the UL6 from the distal cavity of the UL5 (Figure 4).

The aim was to avoid compromising the marginal ridge, keeping it intact at this stage in order to maintain the strength of the tooth.

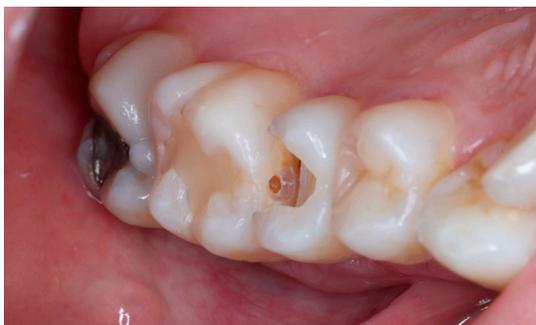
**Figure 5:** Further photographs were taken and shown to the patient. It was explained that a mesial-occlusal restoration would be needed on the UL6

Upon further excavation, it was apparent that caries was present beyond the existing occlusal composite on the UL6. It had extended into the dentine under the existing restoration and also coronally towards the marginal ridge along the internal margins of the restoration. This meant that the existing restoration had failed, despite the tooth appearing clinically sound.

Further photographs were taken and shown to the patient. It was explained that a mesial-occlusal restoration would be needed on the UL6 (Figure 5).

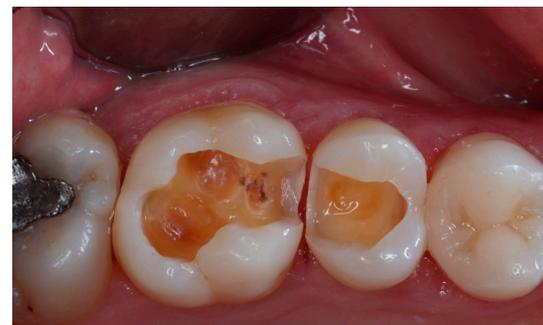
**Figure 6:** Initial cavity preparation was completed on the UL5 and UL6, ensuring the amelodentinal junction was clear of caries by at least 1mm throughout

The disto-occlusal cavity preparation was completed on the UL5. The UL6 mesial-occlusal composite was removed, including all underlying caries. Care was taken to ensure that the amelodentinal junction was clear of caries by at least 1mm throughout (Figure 6). At this stage, the UL6 and UL5 cavity margins were relatively

sharp. These were then bevelled and cavity preparation completed.

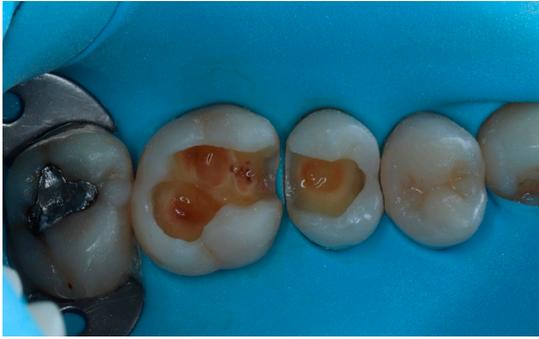
**Figure 7:** The UL5 and UL6 were sandblasted with 27 micron aluminium oxide powder and etched with 37% phosphoric acid gel for 20 seconds

Rubber dam was placed and care was taken to invert it throughout the treatment site. A Coltene Wingless W2 clamp was used on the UL7 to ensure that the working field was easily accessible. The full sextant was isolated, including the UL3. The UL5 and UL6 were sandblasted with 27 micron aluminium oxide powder. The teeth were etched with 37% phosphoric acid gel for 20 seconds (Figure 7).

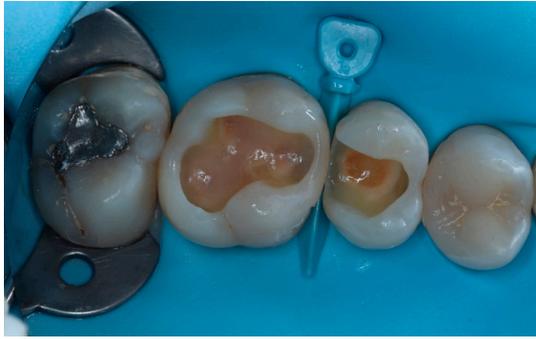
**Figure 8:** A wedge was placed to secure the matrix in position and a slight overhang on the mesiobuccal extremity was removed with a scalpel

The depth of the cavity was measured and an appropriate sectional matrix was selected. I used the Palodent V3 system that, being made of metal, is strong in thin sections. A wedge was then placed to secure the matrix

in position. A slight overhang on the mesiobuccal extremity was removed with a scalpel (Figure 8).

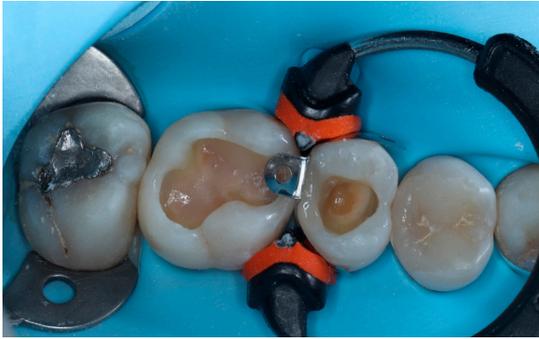
**Figure 9:** When cavity preparations are within the mesial or distal wall curvature, I use a Garrison Composi-Tight 3D ring (3D500), the shape of which engages deep into the interproximal embrasure, buccally and palatally

When cavity preparations are within the mesial or distal wall curvature, I prefer using a Garrison Composi-Tight 3D ring (3D500), the shape of which engages deep into the interproximal embrasure, buccally and palatally (Figure 9).

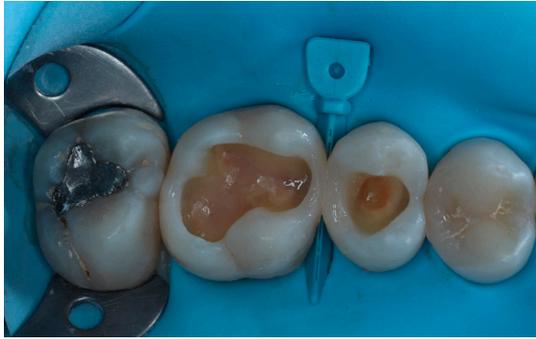
**Figure 10:** Kulzer Venus Diamond works especially well in my hands, offering a high filler content and exceptional mechanical performance and durability

My 'go-to' composite for posterior restorations is Kulzer Venus Diamond. Having used a wide range of materials, I find that Venus Diamond works especially well in my hands, offering a high filler content and exceptional mechanical performance and durability (Figure 10). It also has a longer working time and packs easily in the posterior region.

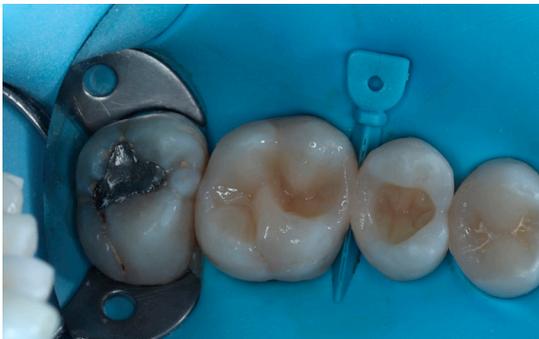
**Figure 11:** The UL5 cavity base was built up and marked in order to guide restoration of the cusps

The UL5 cavity base was also built up and marked in order to guide restoration of the cusps (Figure 11).

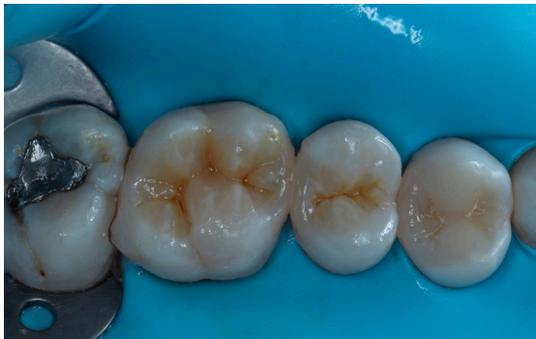
**Figure 12:** Venus Color stains stand the test of time, ageing appropriately with the natural dentition

The final effect was created with a touch of colour using Kulzer Venus Color in choco, white, amber and blue shades. I find that these stains stand the test of time, ageing appropriately with the natural dentition (Figure 12).

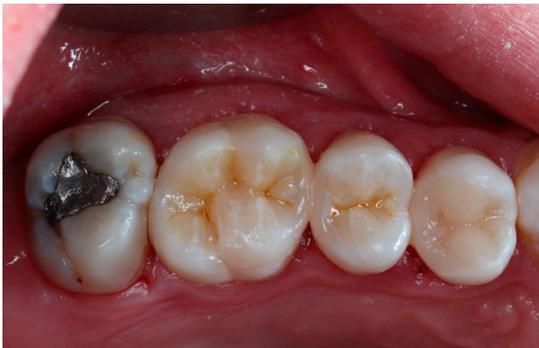
**Figure 13:** The final light-cure was carried out through glycerine gel to prevent the oxygen inhibition layer

With the Venus Color shades applied, the final light-cure was carried out through glycerine gel to prevent the oxygen inhibition layer (Figure 13). The wedge was removed and the restorations were carefully examined for any irregularities, or superfluous or excess composite, after which the rubber dam was removed.

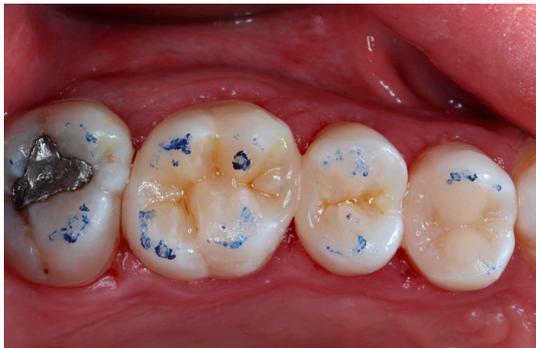
**Figure 14:** Occlusion was checked in the maximum intercuspation position as well as in protrusive and excursive movements

Occlusion was checked in the maximum intercuspation position as well as in protrusive and excursive movements (Figure 14). Heavy contacts were noted on the mesiobuccal cusp incline and on the distobuccal cusp tip, but otherwise good contacts had been achieved throughout the sextant. The heavy contacts were all modified with diamond finishing burs.
