Mimicking nature in gingival recession management

Allan Matthews explains how an aesthetic result can be accomplished for treatment of gingival recession, with appropriate selection of materials and technique

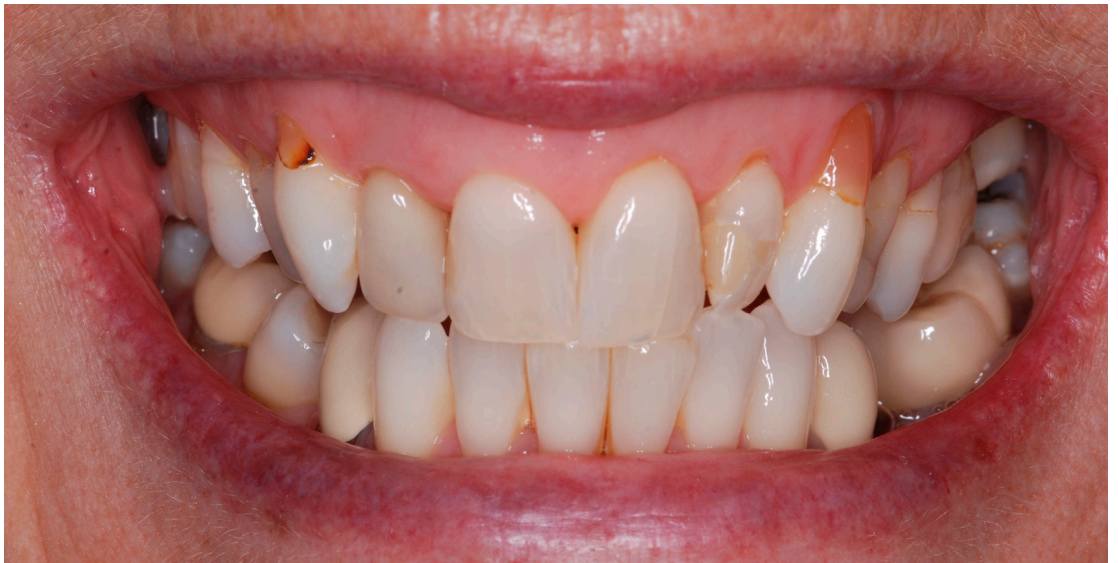
A 67-year-old female patient came to see me who had historically elected to have a gum-coloured composite added to the upper canines (Figure 1).

Her gum recession was likely due to a thin gingival biotype combined with an inappropriate and traumatic toothbrushing technique. The restorations were unaesthetic and the upper right canine (UR3) had suffered marginal failure.

Figure 1: The patient presented with unaesthetic pink composite restorations on the upper canines

The patient chose to have the existing composite on the UR3 removed and replaced with a more anatomical composite restoration. At this time, the patient opted to leave the UL3 untreated.

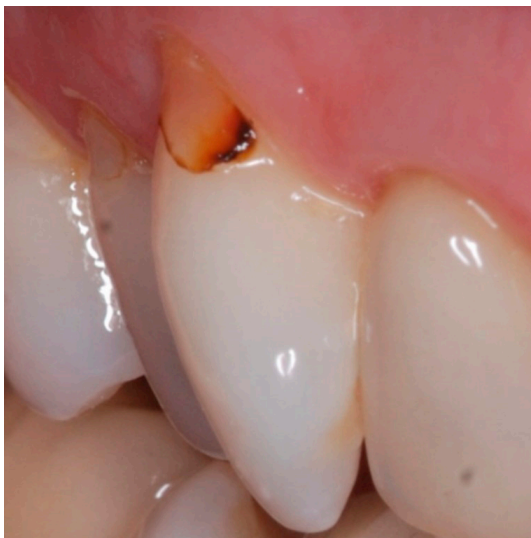
The historic composite had suffered marginal failure and very dark staining was present (Figure 2). The original build-up lacked the necessary thickness, and the translucency of the composite had resulted in excessive shine-through from the underlying tooth and compromised the aesthetic effect.

Figure 2: The historic composite on the UR3 had suffered from marginal failure and very dark staining was present

This may have been a primary causative factor in the dark margins of the former restoration. The surface was air-abraded with 27 micron aluminium oxide and then etched.

The restoration was removed to expose the abrasion lesion and root surface. Non-impregnated gingival retraction cord was then placed into the sulcus. Placement of dry cord ensures that the composite is not contaminated by haemostatic solutions.

Kulzer Venus Pearl Gum shade was placed in a single increment. The gum shade was developed for reconstruction of the gingiva in recession cases. It delivers the same reliable, superior handling and aesthetic benefits as other materials in the Venus Pearl range.

The composite was shaped using a light touch of Kulzer Signum liquid modelling resin to aid with creation of a more natural gingival emergence.

A probe was used to introduce a little stippling to mimic the microscopic elevations and depressions of the gingival surface, though I believe less is more in such instances.

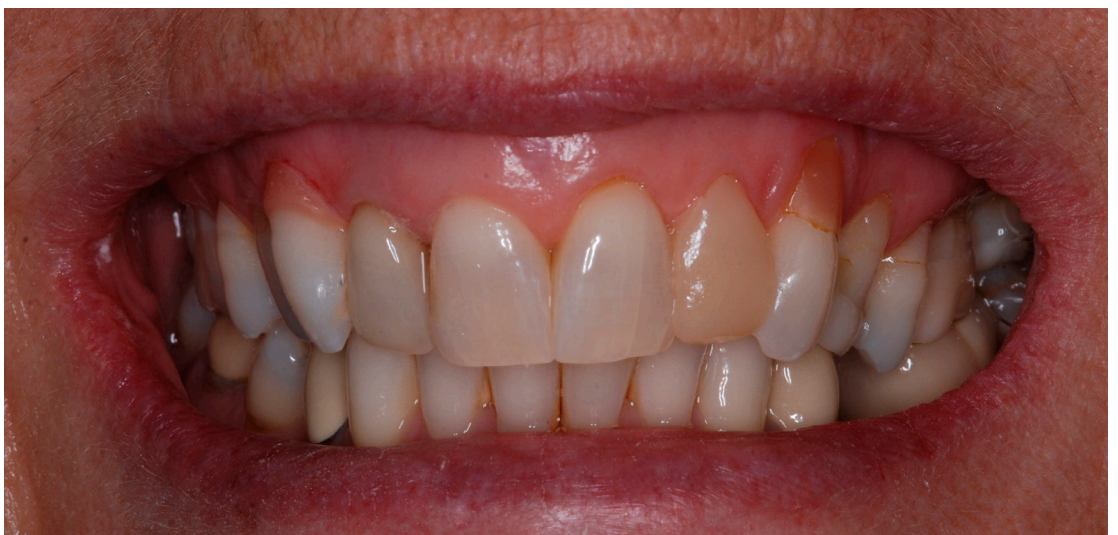
Figure 3: The patient's immediate postoperative smile revealed a more natural effect at the UR3

Figure 3 shows the UR3 immediately following treatment, when a more obvious true margin was evident due to light postoperative bleeding.

The outcome of this case was a much more anatomical and aesthetically pleasing result and the patient's smile now reveals a more natural effect at the UR3.

As the margin is very smooth, excessive plaque accumulation which could threaten the gum is unlikely. However, the patient has been advised not to brush too vigorously, in view of their tendency towards trauma-induced recession.

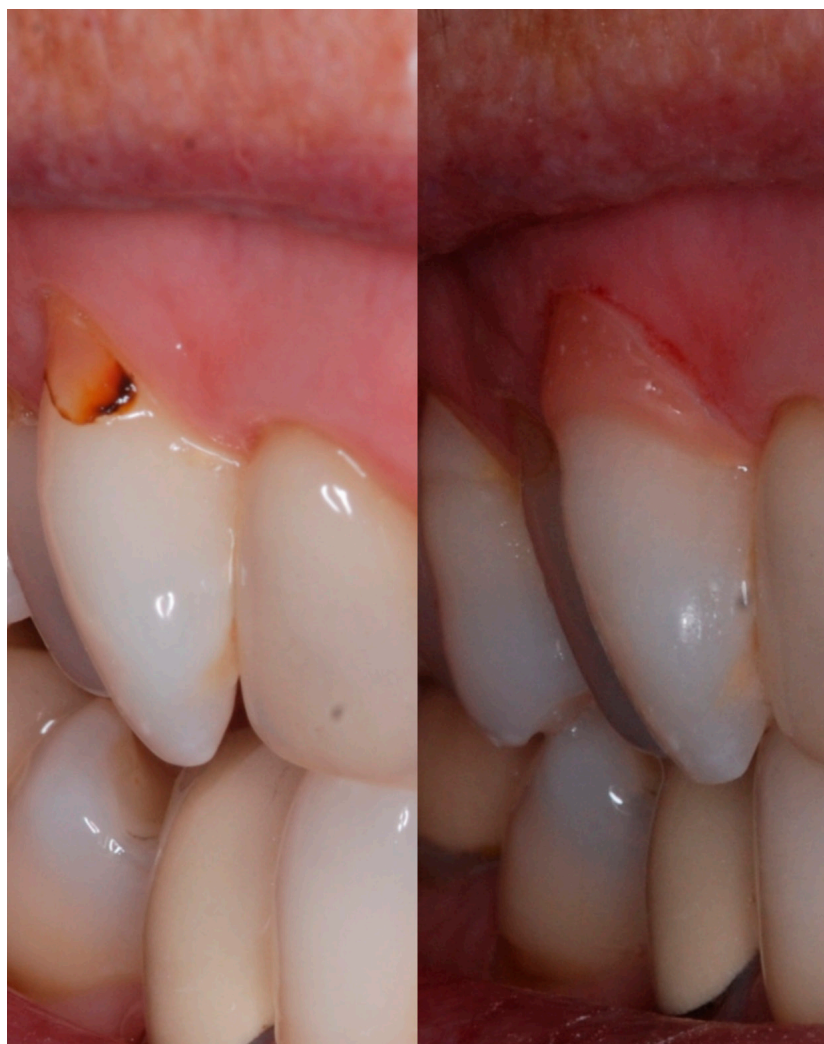
Figure 4: The use of modelling resin to shape the composite and the application of the oxygen blocking agent should mean the new restoration is more resilient

The use of modelling resin to shape the composite and the application of the oxygen blocking agent should mean that the new restoration is more resilient to the issues previously suffered (Figure 4).

The restoration will be monitored in the long term for any signs of such failure. **D**

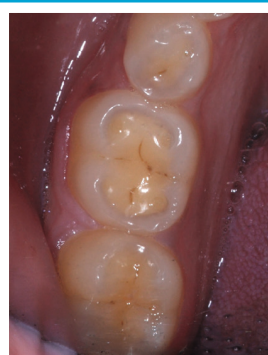
Day of placement

"...no marginal breakdown or wear..."

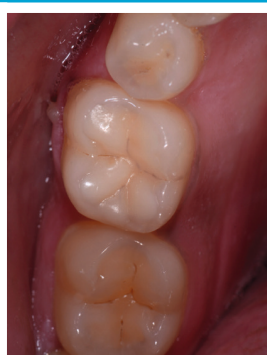
Follow-up, seven years later

“ Seven years on and no marginal breakdown or wear of the material. I have been using Venus Pearl since it was first released in 2012, it has been my go-to composite for posterior composites ever since.
